# Case Study

## Treatment of Non-Healing Diabetic Foot Ulcer with CDO

### Phoenix, AZ

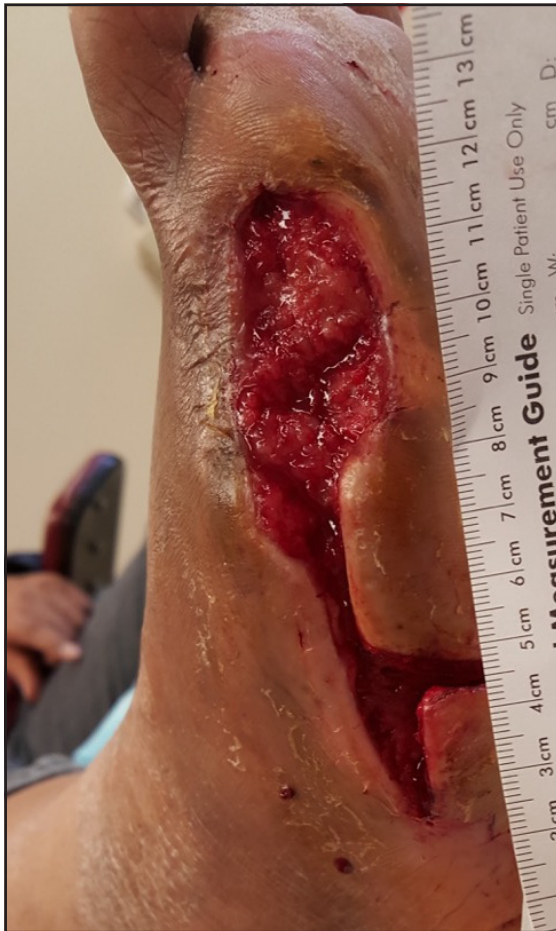
Start of CDO - 10 x 2.5 x 3.0 cm (on Flap)

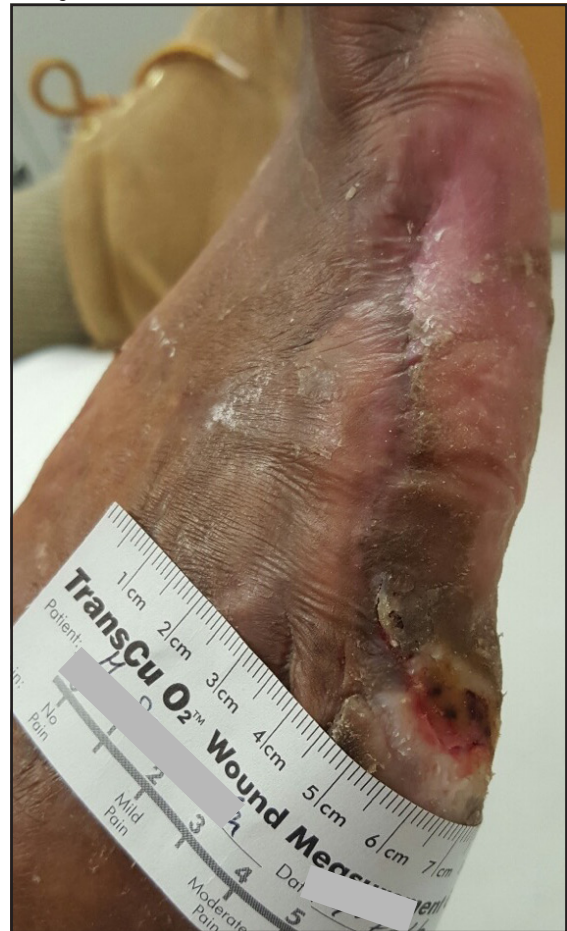
Day 100 - Full Closure

**Outcome:** Wound reached full closure in 100 days with CDO therapy. Patient was DC'd by physician as: Goals met

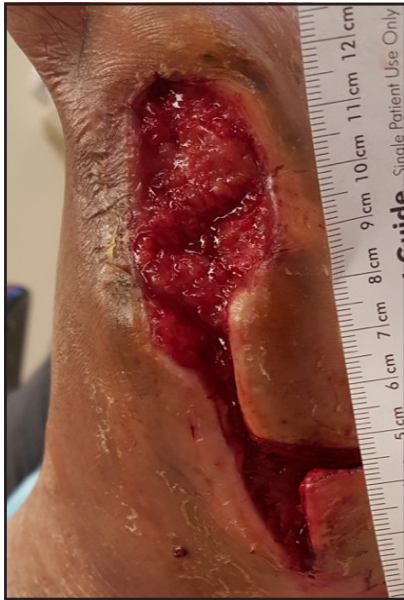
Start of CDO - 10 x 2.5 x 3.0 cm (on Flap)

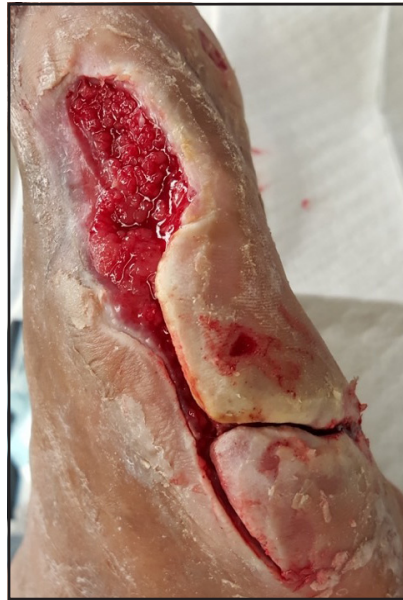
Day 6 of CDO

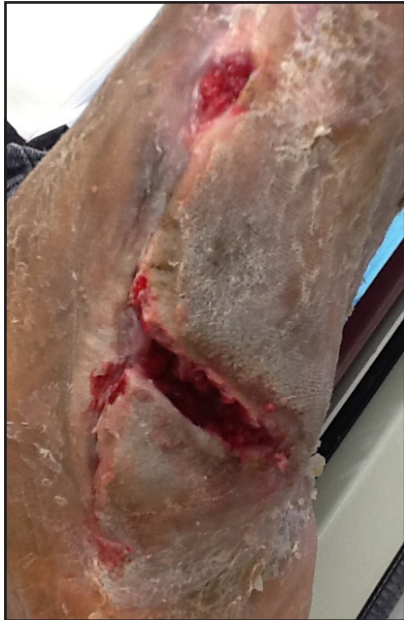
Day 35 of CDO

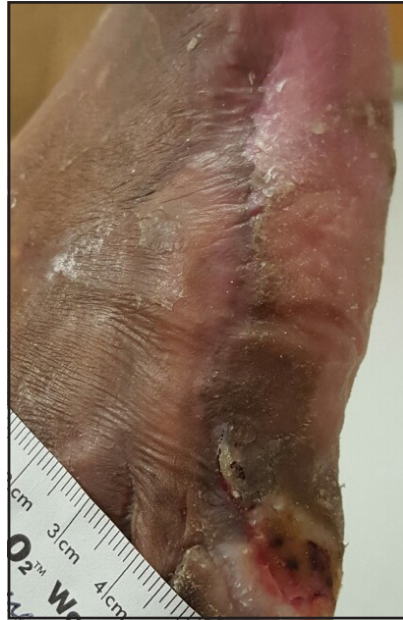
Day 100 - Full Closure
